# Multi-Point Inspection Checklist

RO# 6036838

### Nissan : Rogue : 2020 : All Wheel Drive (USA Production) : 5 Seat with 19" Wheel ExpressAlign Total Alignment

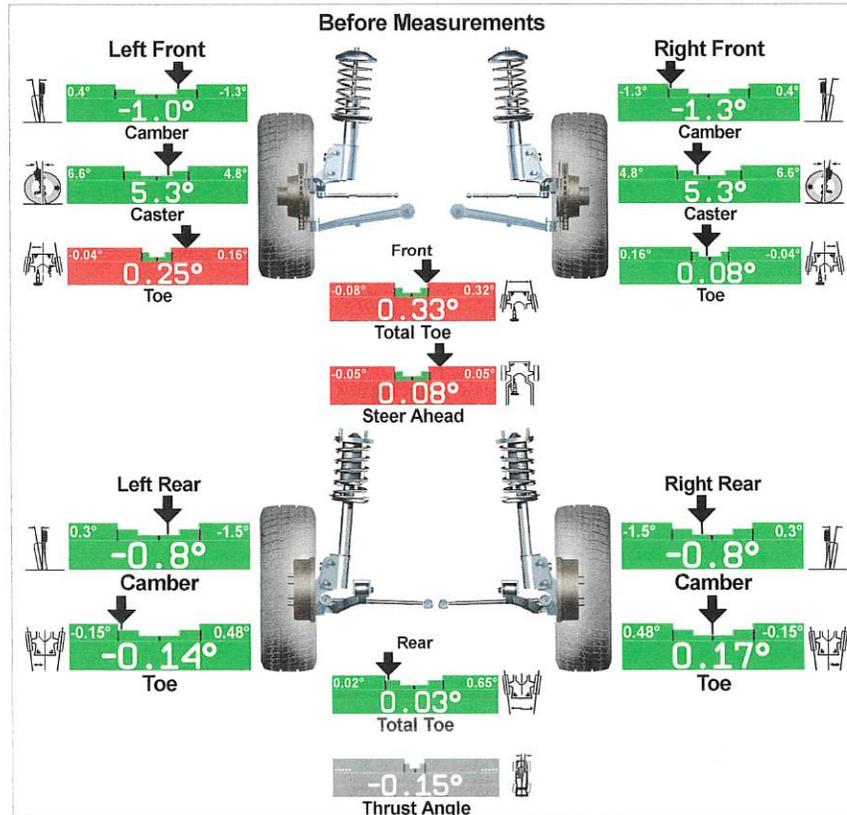
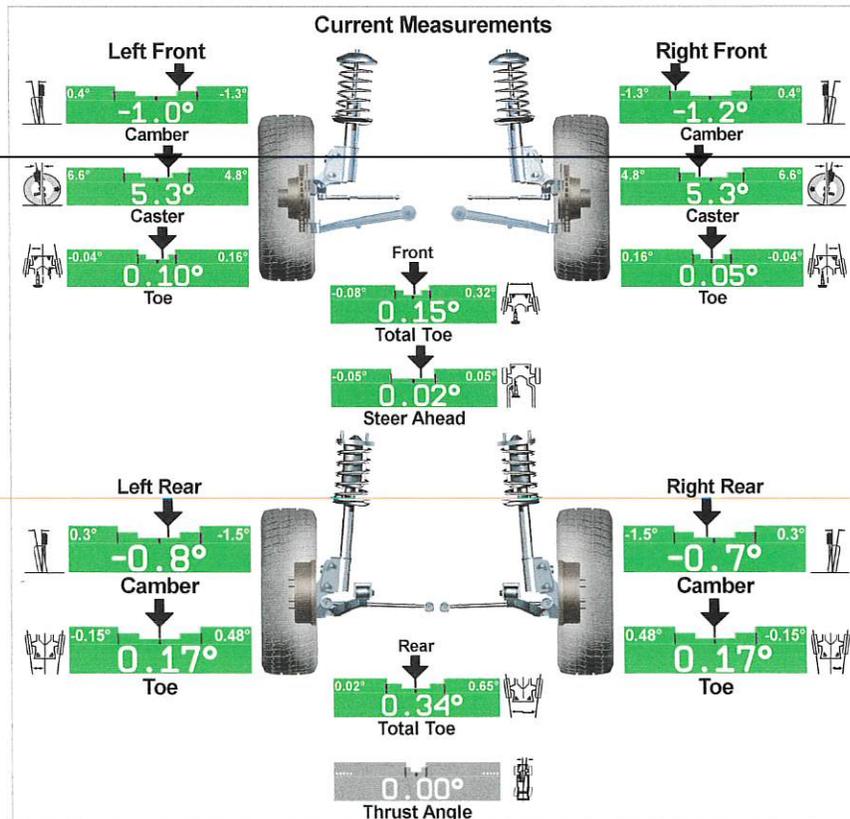
• One or more values are not within specification. Tire wear, handling and safety problems may result.

#6 * ALIGN: COMPUTERIZED ALIGNMENT SERVICE . INCLUDES SETTING CASTER AND CAMBER AND TOE IF ADJUSTABLE. DOES NOT INCLUDE REPLACEMENT OF DAMAGED OR RUSTED COMPONENTS AND OR PART REPLACEMENT . Corrected by ALIGN: COMPUTERIZED ALIGNMENT SERVICE . INCLUDES SETTING CASTER AND CAMBER AND TOE IF ADJUSTABLE. DOES NOT INCLUDE REPLACEMENT OF	I
